Repair of the Signalling Bell

VEVA's 1913 Detroit Electric

by Haakon MacCallum
member of Detroit Committee
Vancouver Electric Vehicle Association

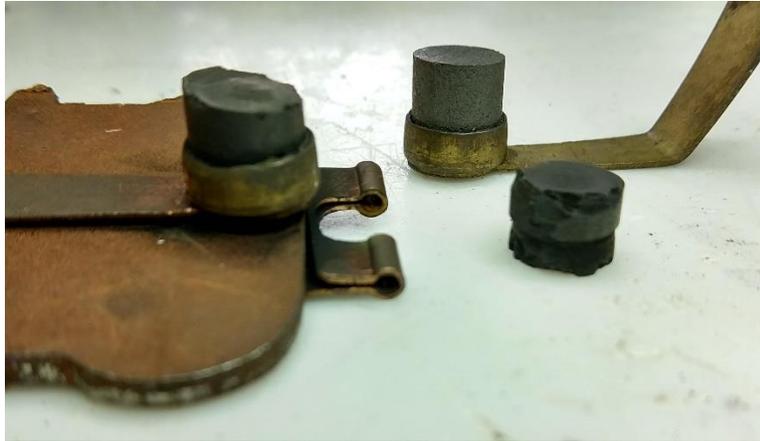
Taking advantage of the opportunity presented by the bell being removed from the car, the cover over the bell electronics was removed, revealing that the carbon brushes were at end-of-life. Both brushes were badly damaged, and one was loose in its holder and ready to fall out.

Figure 1: Old and New Carbon Brushes

To repair the carbon brushes, the carbon portion needed replacement. Carbon brush material was purchased in the form of carbon electrodes. These electrodes were readily available for a low price in a 10mm diameter. No doubt the original brushes were 3/8" (9.525mm) in diameter.

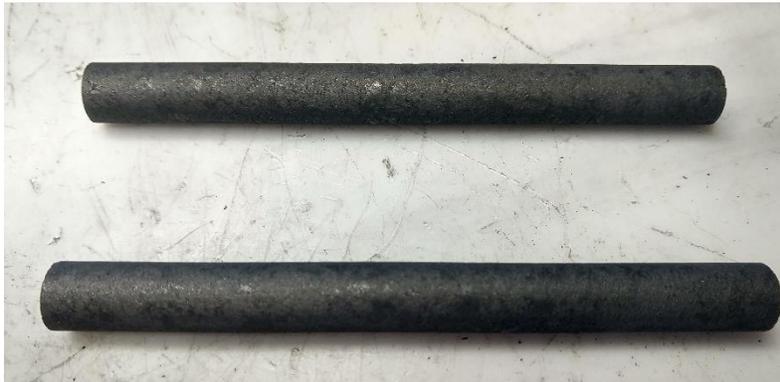
Figure 2: 10mm Carbon Electrodes

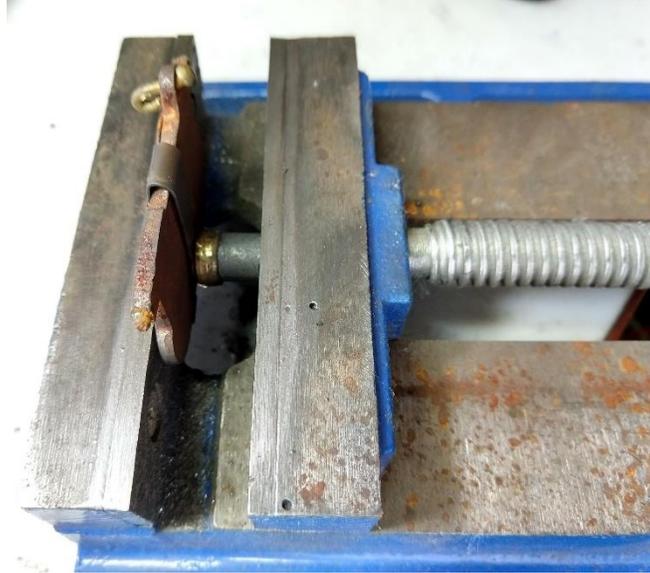
Figure 3: Pressing In New Carbon Brushes

Originally the brushes were likely installed in the holders, which are shaped like a cup, and then crimped in place. However, the new brushes, after being cut to length, were pressed into the holders using a vice. The 10mm diameter was oversized, but excess material scraped off as the brushes were inserted into the holder.

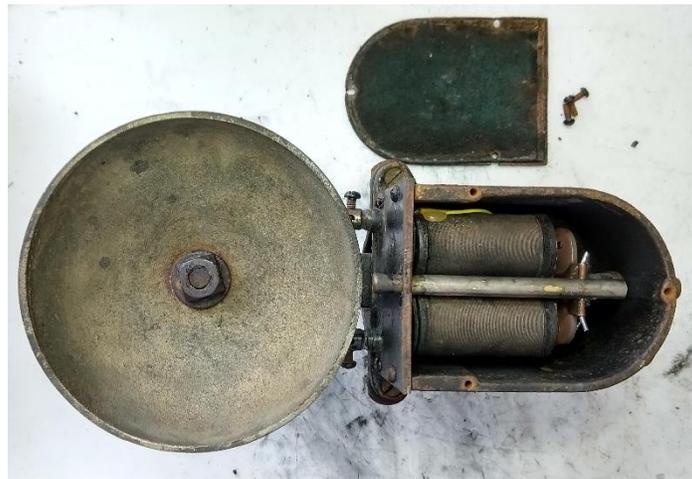
Figure 4: Re-Assembled Bell Mechanism

Once the new brushes were installed the bell mechanism was re-assembled. After assembly, the surfaces of the brushes were filed to properly mate, and the mechanism was greased.

Keen eyes will notice the yellow insulation in the picture. This yellow insulation replaced the old, stiff, cracking insulation that covered the wire from the coil to the brushes. During the repair, the coil end of this insulation was also affixed with hot-melt glue – visible in the picture – to reduce the chance of the wire breaking at the coil end. This was not strictly as the bell was originally manufactured but considered a good way to preserve its life.

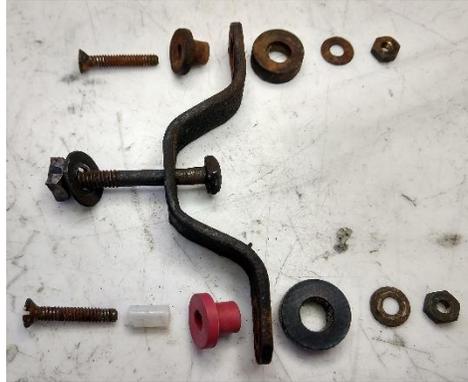
The leakage was likely from contaminants in this insulation system or could have been from the deterioration of the rubber insulation.

Figure 5: Signal Bell Insulation System, Old (top) and New (bottom)

A quick coat of paint and the bell was ready for new insulating bushings. The picture shows the insulation components: a rubber shoulder washer and a rubber washer. The original components are shown with a mounting bracket at the top of the photo – new at the bottom. It turned out that the rubber shoulder washer was identical in all dimensions but the inside diameter to those that

VEVA had manufactured for mounting the 1st speed resistor – these shoulder washers were also used to isolate the body of the resistor from the vehicle chassis. A nylon tube was used to correct the ID. A rubber washer nearly identical in dimensions of the original is used in Galt brand faucets and was readily available at plumbing and builders supply stores.

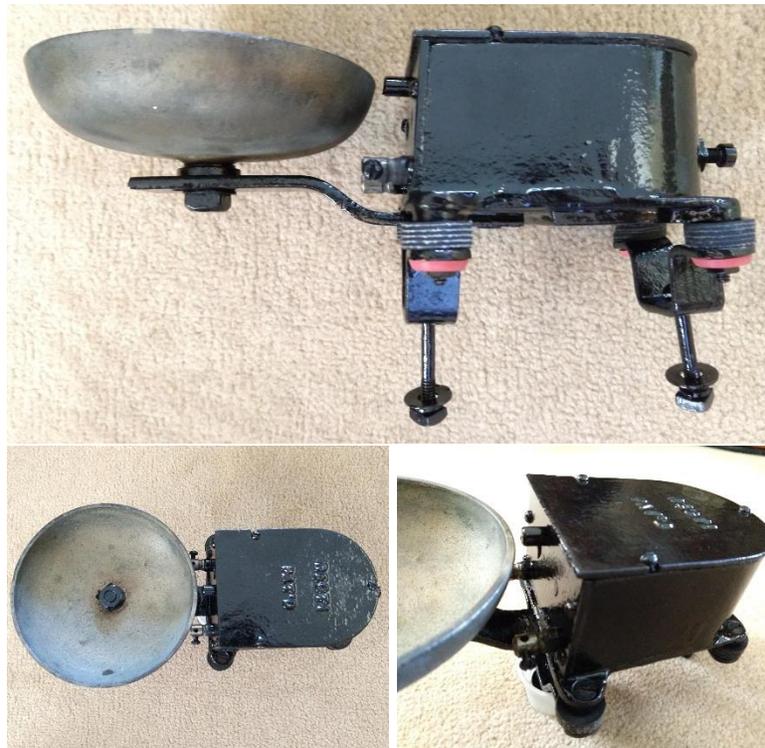
Figure 6: Painted and Assembled Signal Bell

There is an adjustment screw on the end of the body of the bell. This screw adjusts the rate at which the bell is struck (the frequency). Therefore, the screw is adjusted to give the bell a moderately urgent note and locked with the lock nut. Adjusting the supply voltage does not affect the bell frequency but affects only how hard the bell is struck.
